RESULTS: Validation and reparation

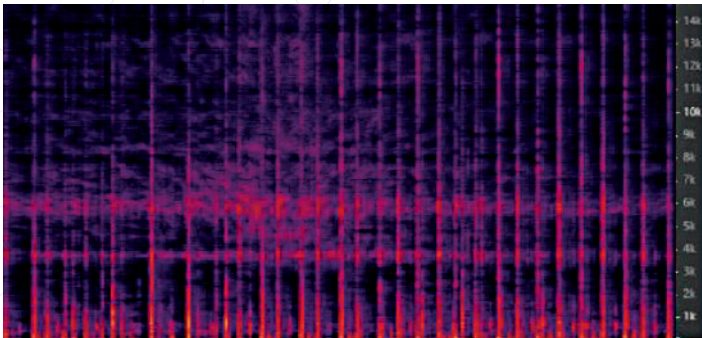
Leak 1

Once the information collected in both sections was analyzed, the final report showed the existence of two leaks, one anomaly and their exact location in the inspected section. Once the location of the leaks was confirmed, the ATL technicians proceeded to carry out the corresponding openings at the two marked points to proceed with their repair and, consequently, recover the flow rates of maximum use of the network.
